ALFREDO'S CAFE  
ALBUQUERQUE, NM

INVESTIGATION

## SOUTHWEST GHOST HUNTERS ASSOCIATION

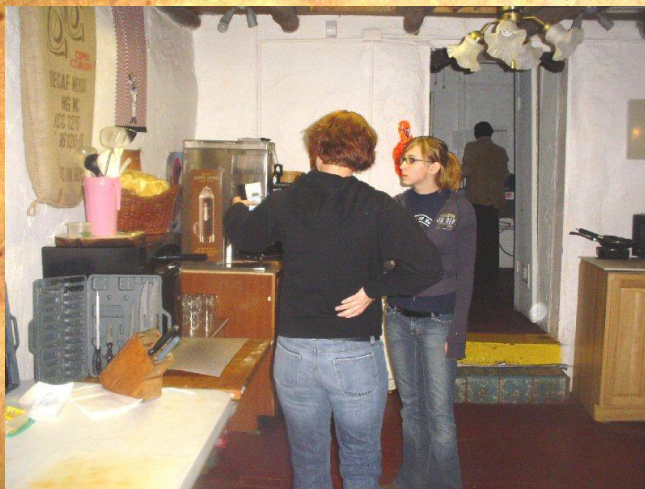
The electrical demands of the cafe may often exceed that of the breakers in the electrical box causing them to trip or possibly not receiving enough voltage to properly function them. It was also noticed that the light in the men's bathroom flickered whenever the cappuccino machine was operating. An inspection of the circuit breaker box

revealed several breakers to be double tapped. One of the double tapped wires had become loose. Loose conductors can lead to overheating; arcing and cause the momentary power issues that were reported to occur in the building.
